Forest Pest Management Report

R-3 91-7

EVALUATION OF POTENTIAL HAZARD
TREES AND PEST CONDITIONS
AZTEC RUINS NATIONAL MONUMENT
AZTEC, NEW MEXICO

MAY 1991

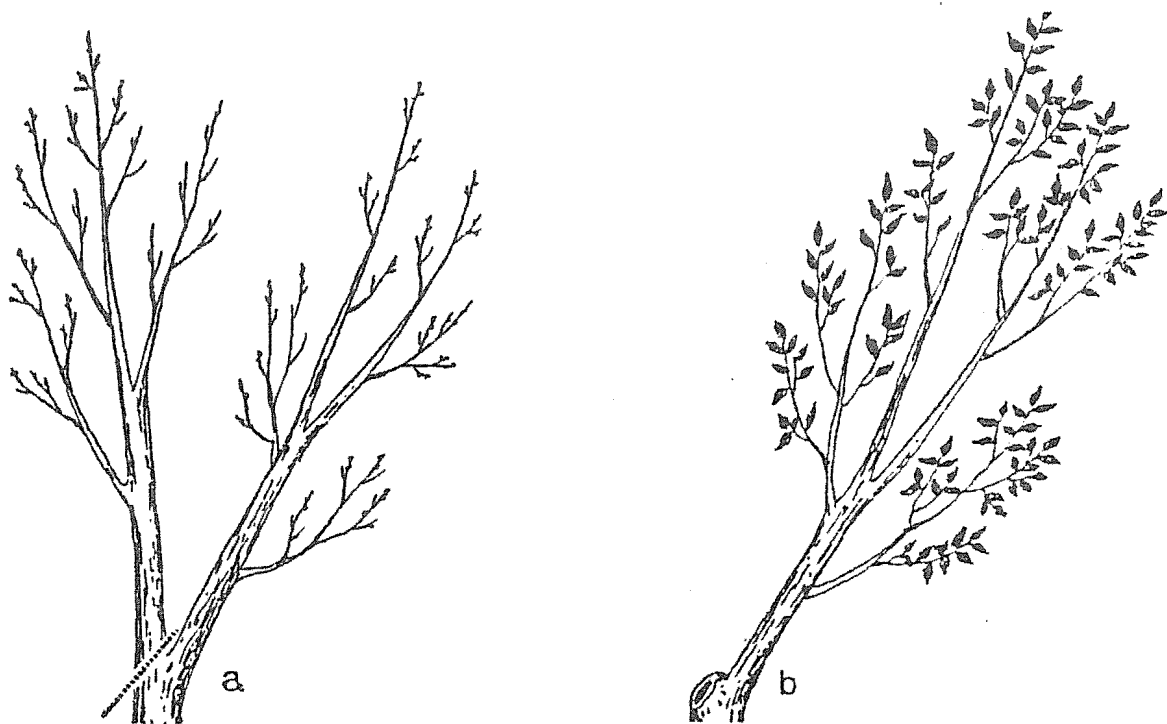
Figure 1 a. Drop-crotching to remove a limb. Remaining leader will produce foliage (b) to inhibit latent shoots and encourage callus growth over wound.

failure. When pruning hazardous branches on hardwoods, such as cottonwoods and elms, drop-crotching (Figure 1, Appendix) is preferred over topping (Figure 2, Appendix). Remaining leaders on drop-crotched trees will produce foliage to inhibit latent shoots, encourage callus growth over wounds, and add to the longevity and attractiveness of the tree. Unlike drop-crotching, topping results in rapid sucker growth. Such shoots are weak and destroy the natural shape of the tree. For trees showing signs of internal decay, the thickness of sound wood in the outer shell determines relative safety. Trees that lean naturally usually are reinforced by compensatory growth. However, structural damage to leaning trees, such as severed roots, large basal cavities, and internal decay increase the probability of failure and threaten visitor safety (Johnson, 1981).

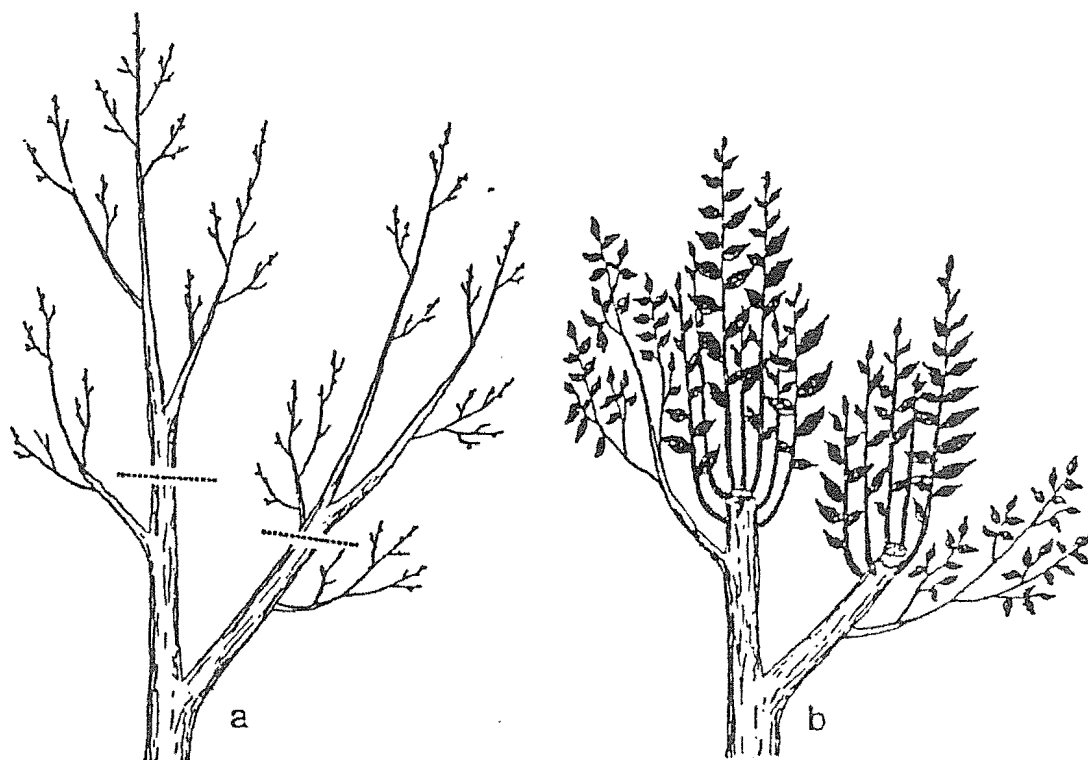
Figure 2 a. Topped trees will result in rapid sucker growth from latent buds (b). Such shoots are weak and destroy the natural tree shape.
